Inspection Report

Property Address:
108 Conway Court
 Mooresville NC 28117

Envision Home Inspections, LLC

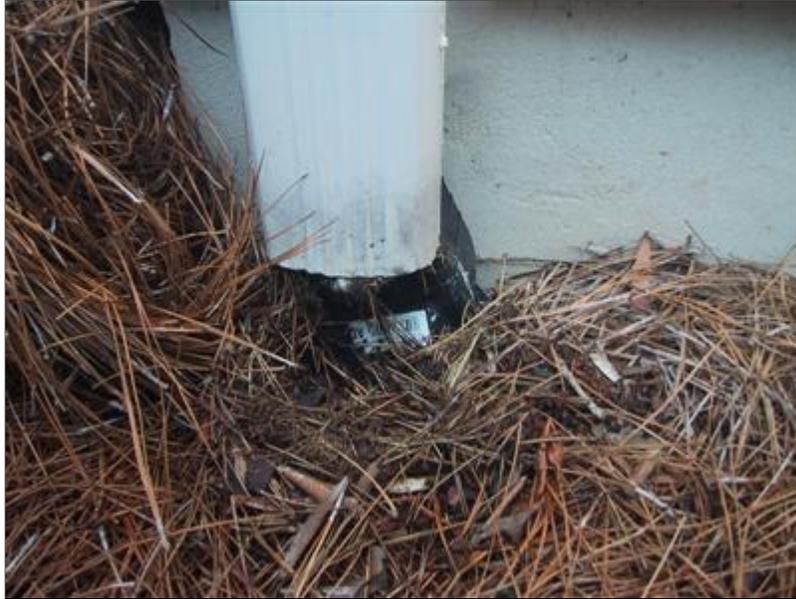
1.3 Picture 1

The downspout on the left side of home (if facing it from front), and behind the air condensers, is full of debris and needs to be cleaned. Recommend repair by a qualified individual

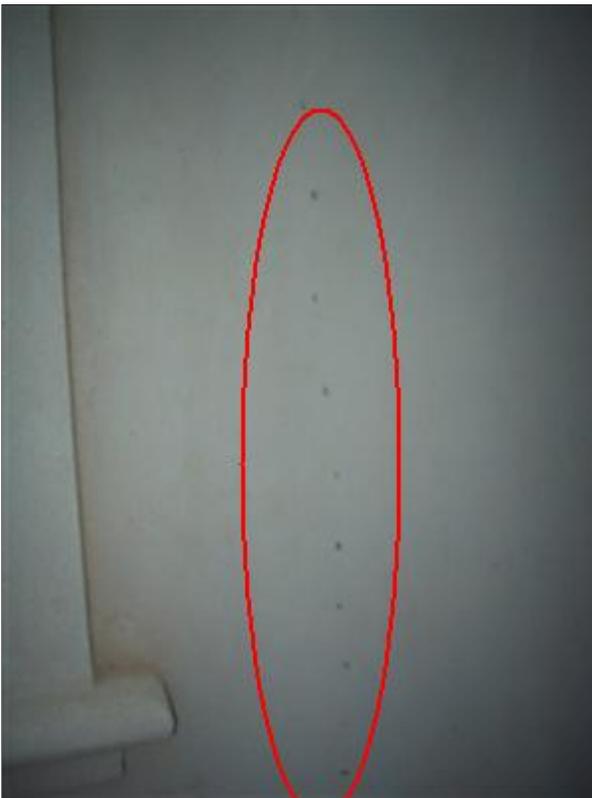
2.0 Picture 1

On the left side of home (if facing from front), there are chips in the hardcoat stucco on either side of the garage window. This should be repaired as it could lead to moisture problems and subsequent mold growth which accompanies it.

Recommend repair by a qualified person/contractor.

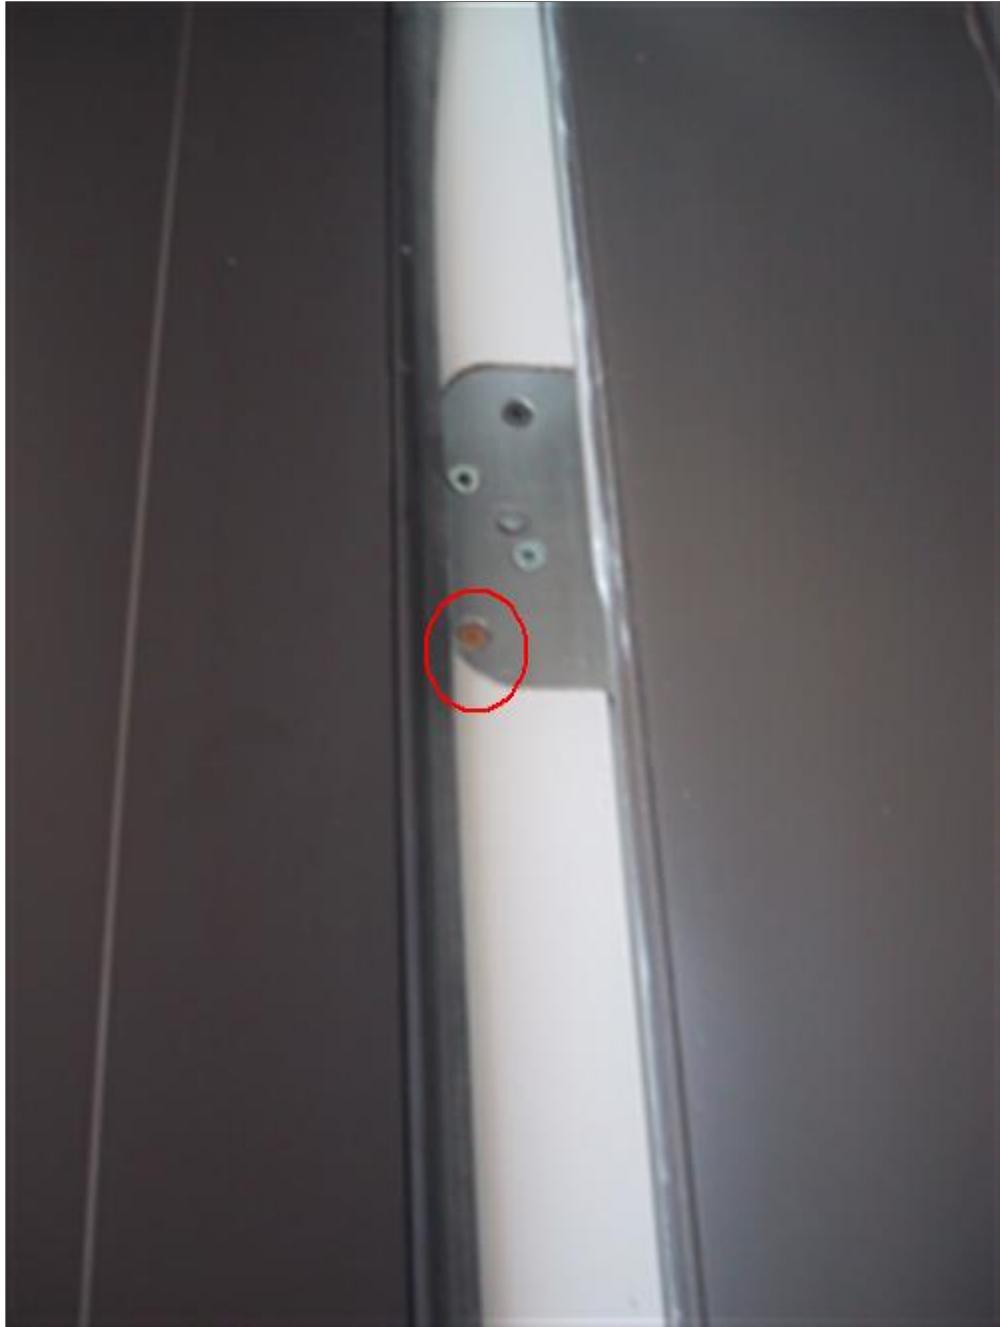
2.1 Picture 2

(1) The entry door to the detached garage needs to be adjusted. I had to "pull up" on the door to get it to latch. Recommend repair by a qualified person/contractor.

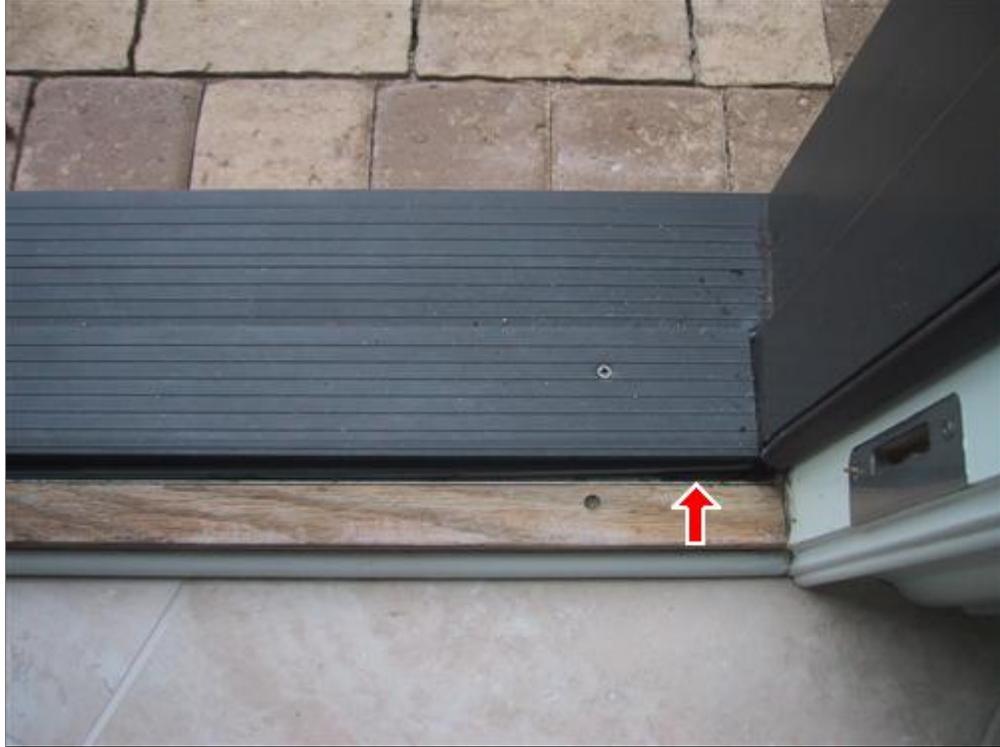
2.1 Picture 3

(2) The **hinged** doors on the main floor which lead to the pool area have warped internal water pans. These pans prevent rainwater from entering through the top of the threshold and thereby going underneath the threshold. Sometimes they warp due to many reasons, mainly temperature, humidity, and loss of adhesive which anchors them. It is of potential interest on these two doors, as they are not covered by porches or a roof structure like many other doors on this home.

Recommend sealing the void area(s) with clear silicone by a qualified person.

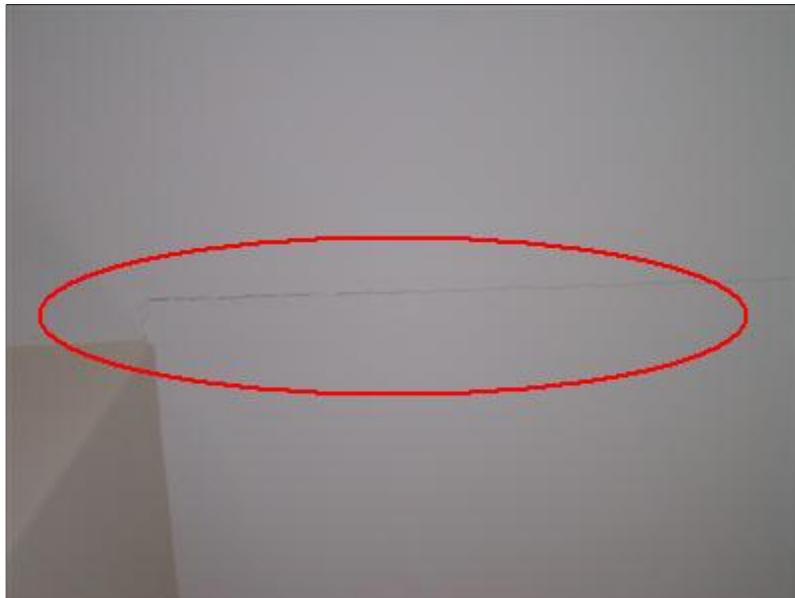
3.0 Picture 1

The ceiling in the detached garage has a long "stress" fracture in the sheetrock. This could be due to expansion/contraction of the ceiling joists, or possibly could be due to the load being applied from the walkway gable ridge falling directly on the ceiling joist and causing displacement. There was no scuttle hole to the detached garage attic area that I could find to properly evaluate.

Recommend repair of sheetrock/paint by a qualified contractor/person. If situation persists, invasive measures might have to be taken to properly rectify.

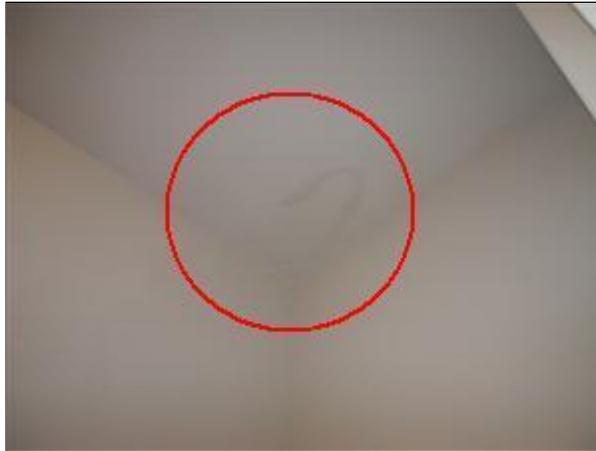
4.0 Picture 1

The ceiling area in the closet of Bedroom 1 (first at top of stairs), has a water stain on it in the corner. I went into attic to try to find where this may be coming from. There were no visible condensate lines in the area, so the probability that it came from a shingle/flashing problem is high. However, I could not specifically locate the source. This could be an active leak, or could have already been fixed and the paint repair just overlooked, as it was dry to the touch. Recommend the ceiling paint be touched up, and further monitoring after heavy rains.

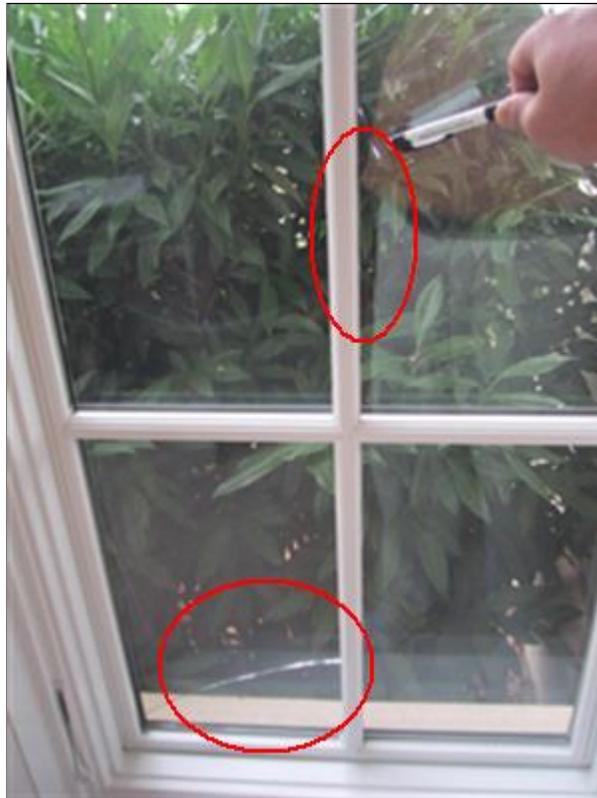
4.6 Picture 1

The right-most window (if standing in the kitchen looking at lake, not pool) has two areas of broken glass. Recommend replacement by a qualified person/contractor.

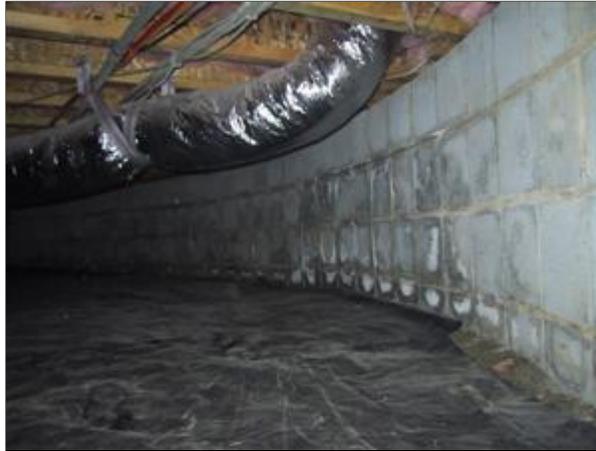
5.0 Picture 1

(1) White efflorescence (powder substance) on block wall indicates moisture is in contact with the masonry. This does not necessarily indicate that intrusion will occur. I recommend checking the gutters and the downspout drain lines for proper operation. Also, a water proofing paint could be applied to the interior side of the block if necessary. Efflorescence is found on many homes without water intrusion occurring inside the home. But, it should alert you to the possibility that future steps may be needed. This is located directly underneath front gallery where the curved wall adjoins the porch area outside at the pool.

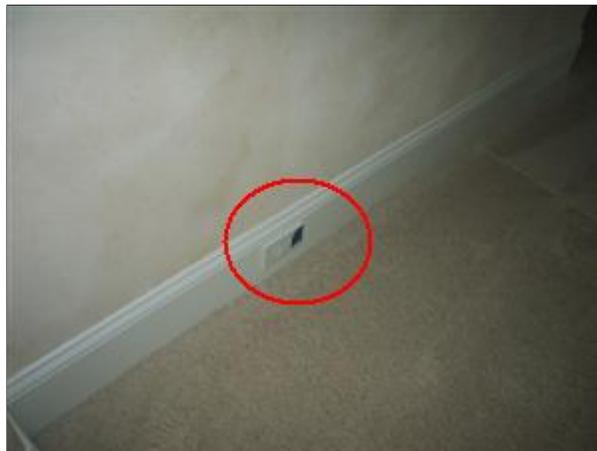
7.3 Picture 1

Comments:
(1) The outlet in the hallway on the 2nd floor leading to the bedroom and exercise room did not show any voltage or current to it. Recommend evaluation and/or repair by a qualified person/electrician

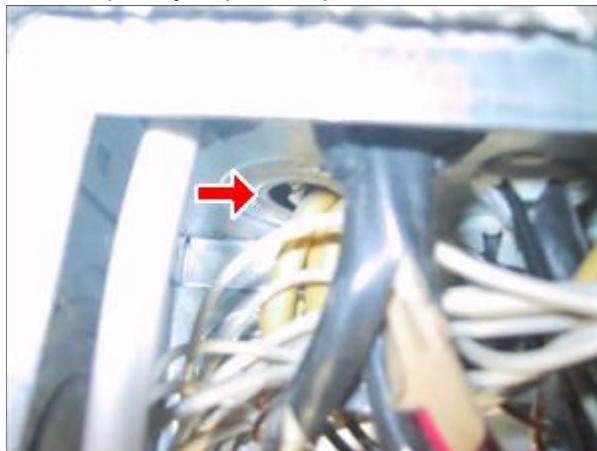
7.3 Picture 2

(2) In subpanel A in the attached garage closet, there is a circuit missing its bushing collar. Although this might seem minimalistic, the bushing prevents the sharp metal edges from cutting into the wire insulation and starting a short. Recommend repair by a qualified person/electrician.

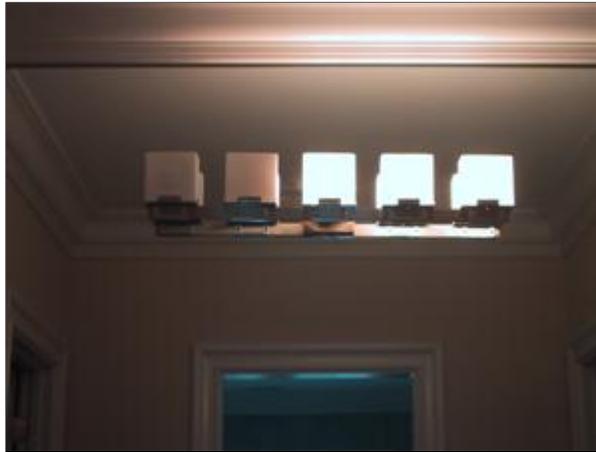
7.3 Picture 3

(3) There were numerous switches in which I could not ascertain what they controlled. **They are marked with blue painters tape.** Also, there are numerous lights either missing or burned out, on the exterior as well as interior. (left side of home *in the crawlspace* as well). Here are some possibilities for the marked switches:

I recommend replacement of bulbs where necessary. If new bulbs do not solve the problem, the circuit needs to be evaluated/repared by a licensed electrician. One possible method to determine all of the electrical feeds is to get the original electrical blueprint/schematic from the builder, Simonini Custom Homes.

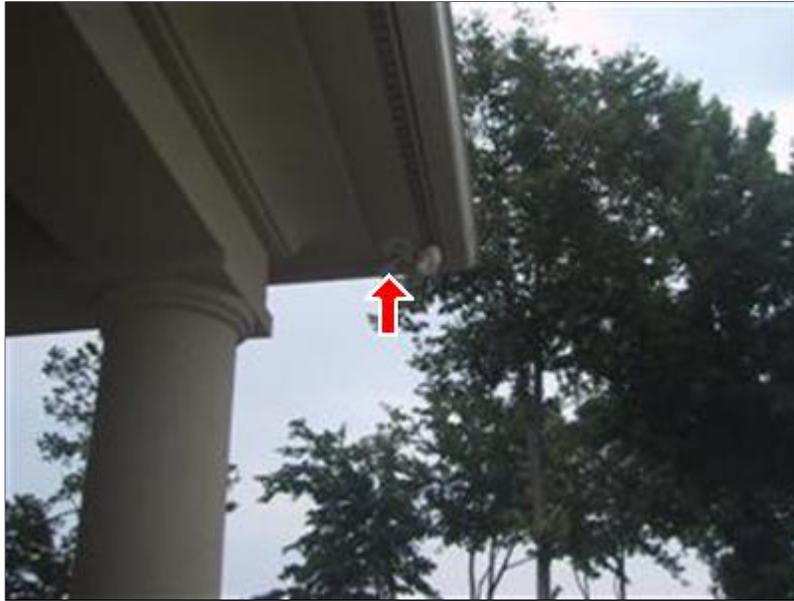
7.3 Picture 5 missing floodlight

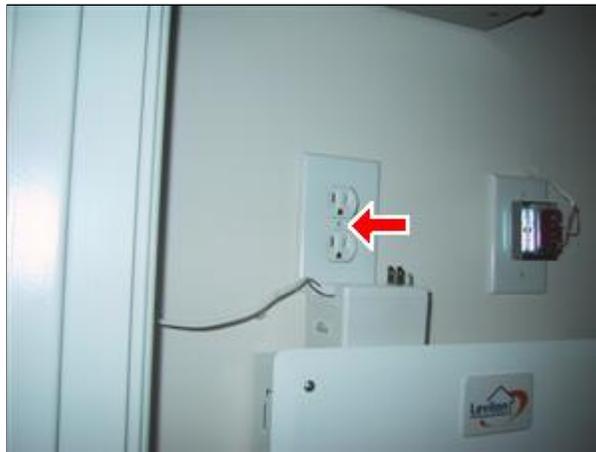
7.3 Picture 6

(4) Several outlets in the A/V room off the kitchen area are missing plate screws. Recommend repair by a qualified person/electrician

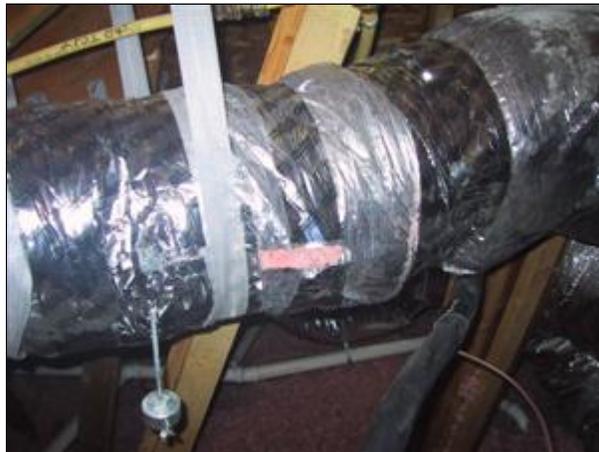
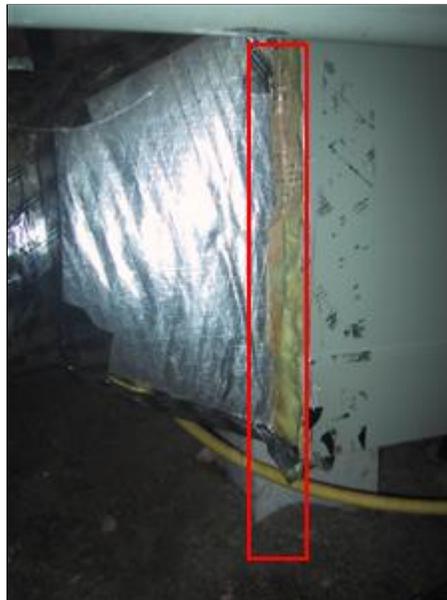
(1) There are two areas in the ductwork which need to be sealed. Although this may seem minimalistic, sealing these areas with approved tape will prevent moisture accumulation in the insulation, and reduce the effect of ambient heating on the ductwork.

Recommend repair by a qualified HVAC contractor.

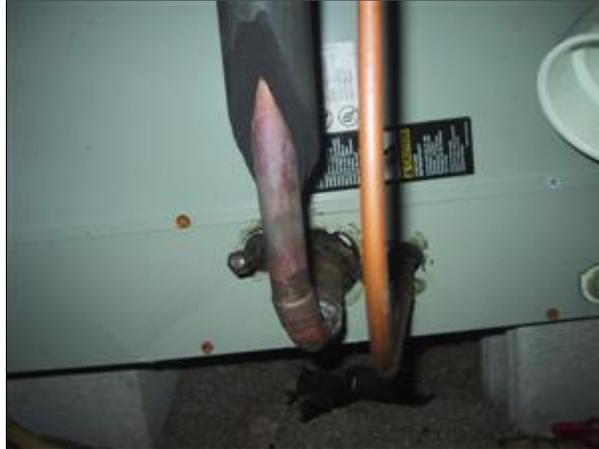
8.3 Picture 3

(2) The insulation on the line set on the furnace underneath the kitchen needs to be repaired and extended to the face of the furnace. Recommend repair by a qualified HVAC contractor.

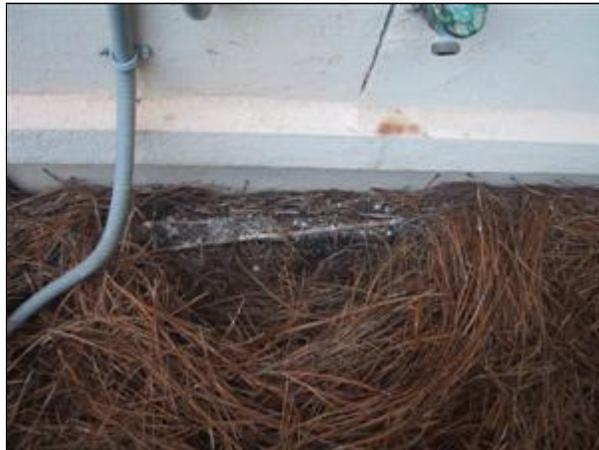
8.3 Picture 4

(3) The insulation on the line set to the exterior condenser pumps on the left side of home behind garage was buried, causing the insulation to deteriorate. Recommend repair by a qualified HVAC contractor.

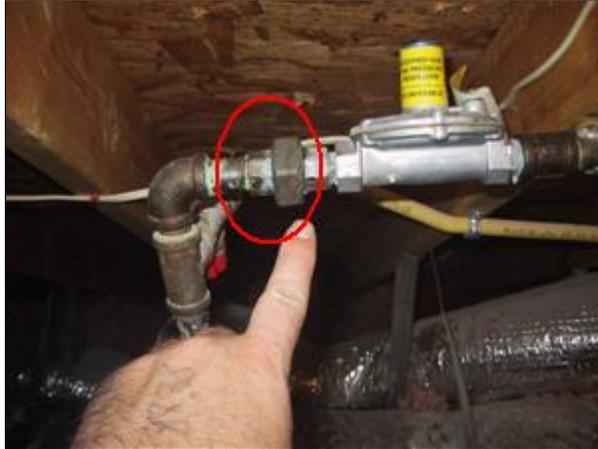
8.5 Picture 1

Noticed (by smell) a small leak at the lock nut just before the regulator in the attic area next to furnace.
Recommend repair by a qualified HVAC contractor

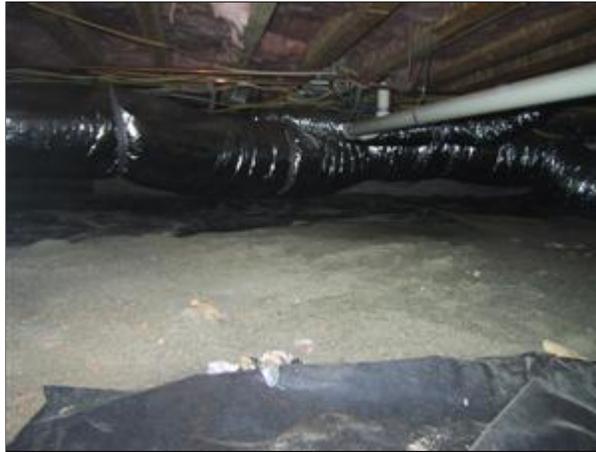
9.2 Picture 1

There are several areas in the crawlspace (especially under the left side of home/kitchen area) which need the vapor barrier repaired/recovered. The moisture levels in the crawlspace were good, but repairing this will add further moisture protection.

Recommend repair by a qualified person.

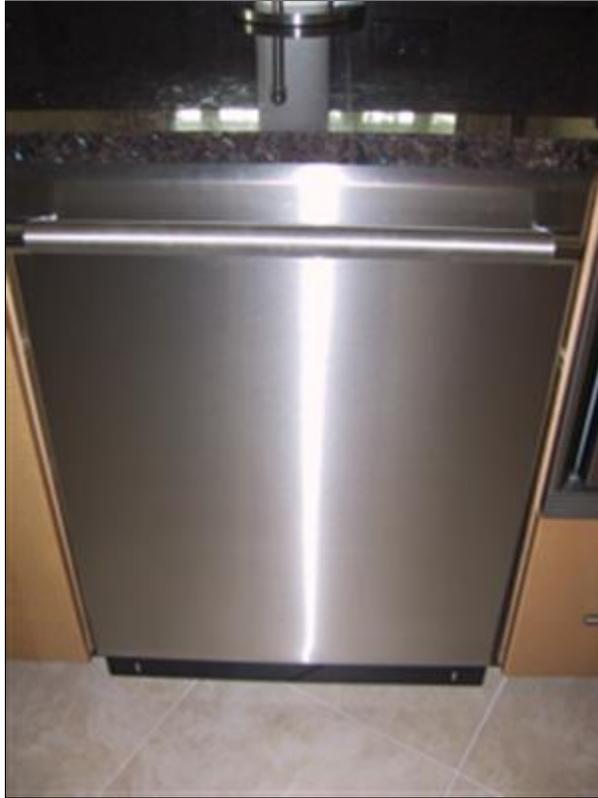
10.0 Picture 1

The dishwasher to the right of sink (if looking at sink) is hard to open. Based on further inspection, it is because the rubber flange at the bottom does not extend far enough over the bottom flange of the door, causing the rubber to "pop" once the door is opened far enough. This could be a manufacturer defect, as there appears to be no adjustment mechanism to manually alleviate this. Recommend further evaluation and/or repair by a qualified person/contractor.

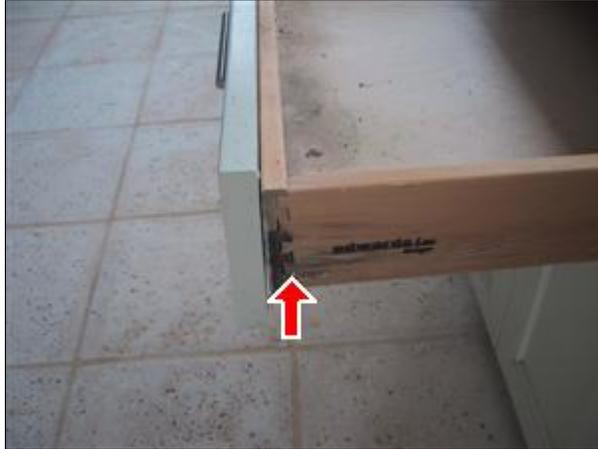
12.1 Picture 1

The outdoor cabinetry and some of the drawers are warped and are coming apart at the dovetail joints. In addition, some of the surfaces inside the cabinets have mold growth in them. Recommend replacement of all cabinets/drawers which need it, as repair of these types of joints usually does not work.

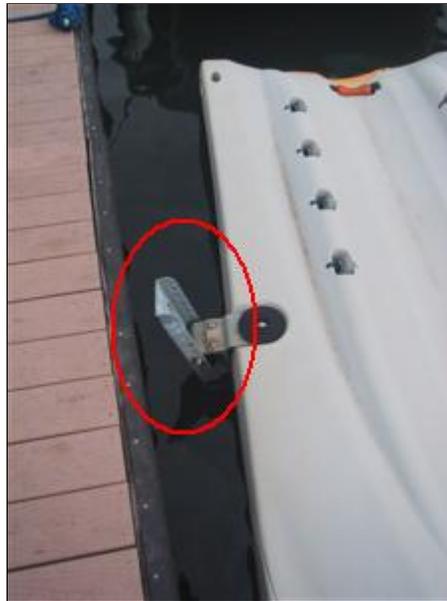
13.3 Picture 1

(1) The connector for the watercraft vessels has become detached from the deck. Recommend repair by a qualified person/contractor.

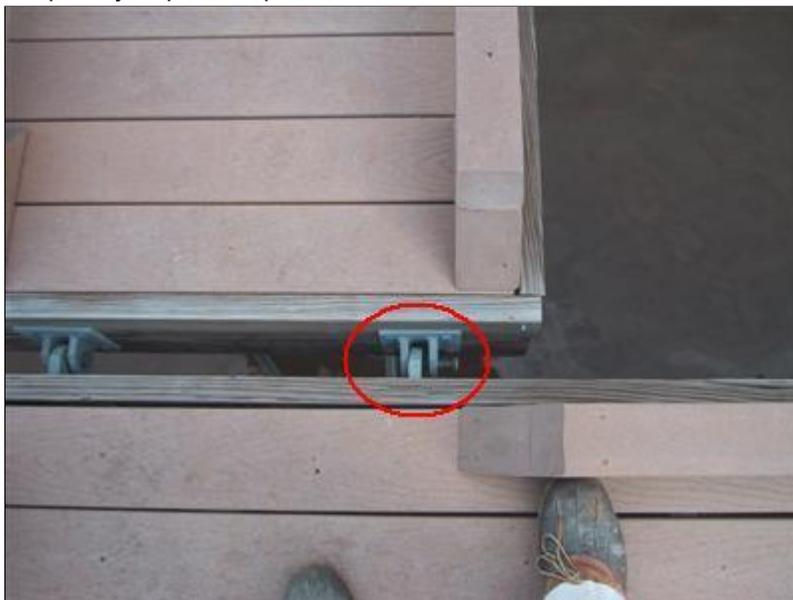
13.3 Picture 2

(2) The right hand bolt which attaches the "gangplank access ramp" to the boat dock apparatus is coming loose. Recommend repair by a qualified person/contractor.

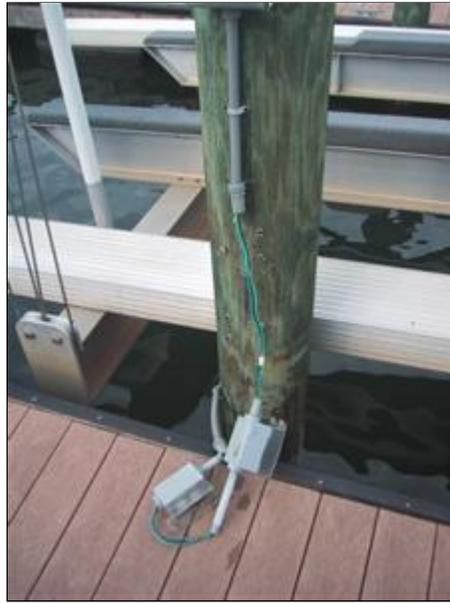
13.6 Picture 1

The GFCI outlet and circuit to power the lift are damaged. Recommend repair by a qualified electrician.

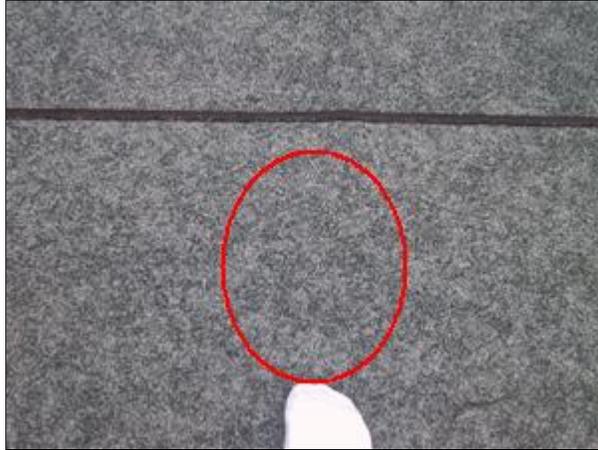
1.0 Picture 1

There were several areas over the covered back porch (covered with roll roofing) which exhibited "bubbling", although I could see no readily apparent holes. This will need to be monitored further, as roll roofing is more susceptible to leaks at seams and "bubbling", and typically has a shorter life span than conventional asphalt/fiberglass shingles.

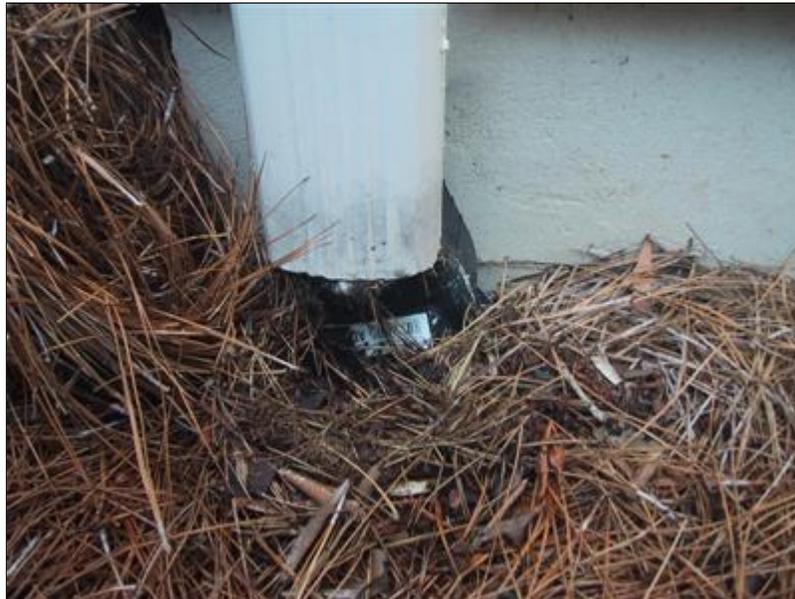
1.3 Picture 1

The downspout on the left side of home (if facing it from front), and behind the air condensers, is full of debris and needs to be cleaned. Recommend repair by a qualified individual

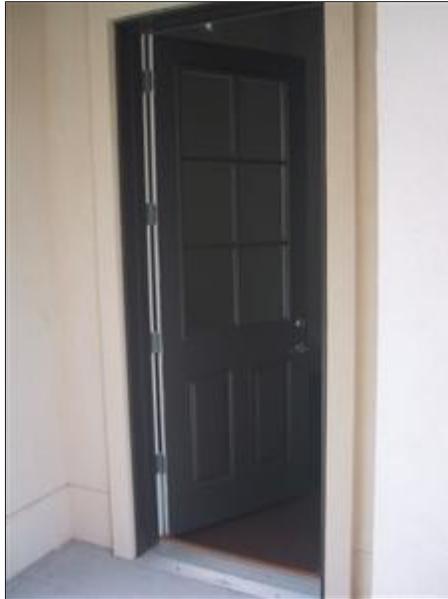
2.1 Picture 1

(1) The entry door to the detached garage needs to be adjusted. I had to "pull up" on the door to get it to latch. Recommend repair by a qualified person/contractor.

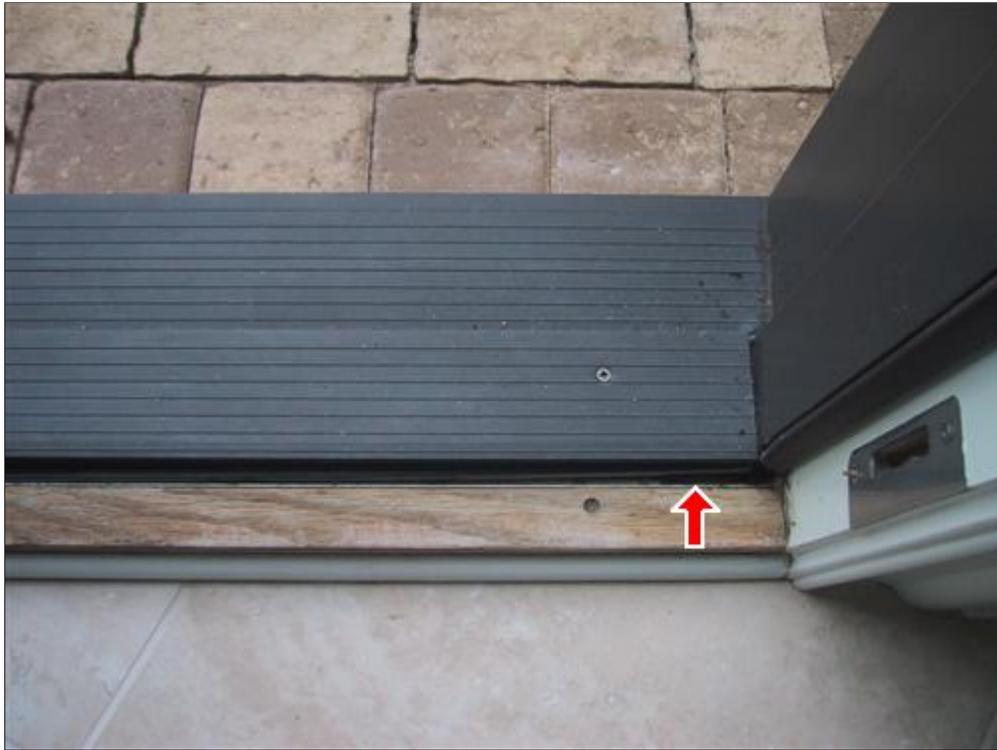
2.1 Picture 3

(2) The **hinged** doors on the main floor which lead to the pool area have warped internal water pans. These pans prevent rainwater from entering through the top of the threshold and thereby going underneath the threshold. Sometimes they warp due to many reasons, mainly temperature, humidity, and loss of adhesive which anchors them. It is of potential interest on these two doors, as they are not covered by porches or a roof structure like many other doors on this home.

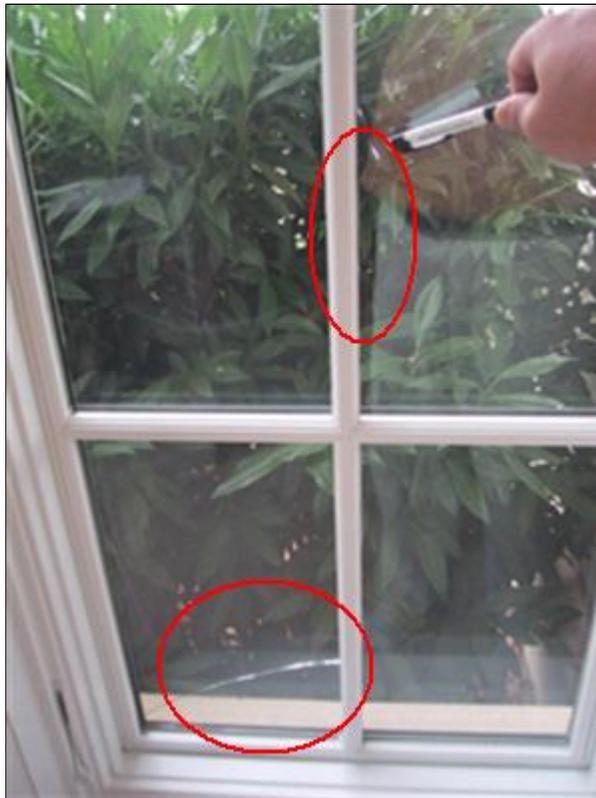
4.6 Picture 1

The right-most window (if standing in the kitchen looking at lake, not pool) has two areas of broken glass. Recommend replacement by a qualified person/contractor.

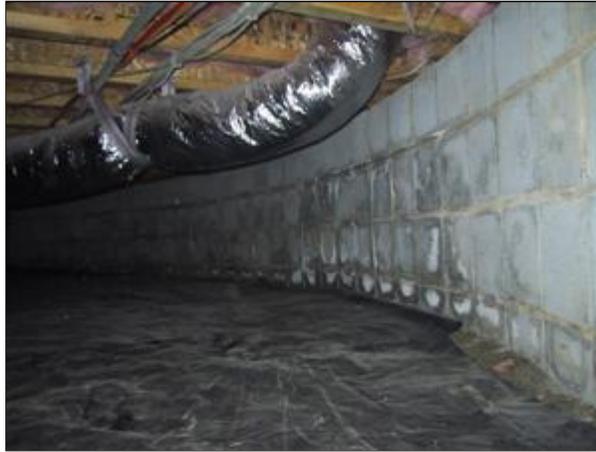
5.0 Picture 1

(1) White efflorescence (powder substance) on block wall indicates moisture is in contact with the masonry. This does not necessarily indicate that intrusion will occur. I recommend checking the gutters and the downspout drain lines for proper operation. Also, a water proofing paint could be applied to the interior side of the block if necessary. Efflorescence is found on many homes without water intrusion occurring inside the home. But, it should alert you to the possibility that future steps may be needed. This is located directly underneath front gallery where the curved wall adjoins the porch area outside at the pool.

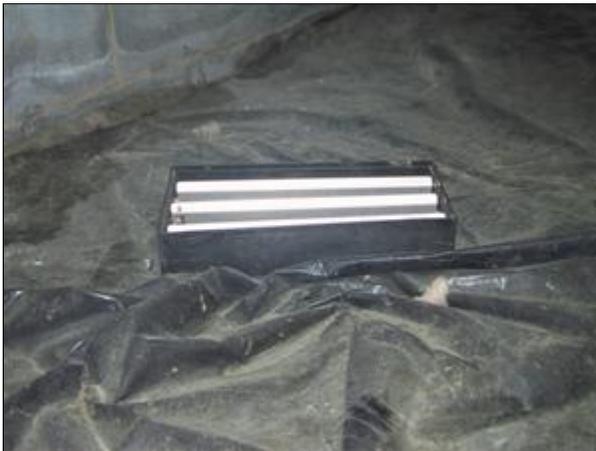
5.0 Picture 2

(2) In the crawl, there are several automatic damper/louvers which need to be replaced/re-attached to the their respective vents.

Recommend repair/replacement by a qualified person/contractor.

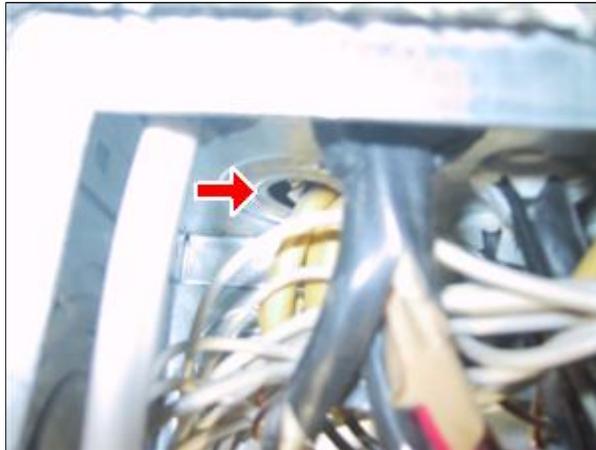
7.3 Picture 2

(2) In subpanel A in the attached garage closet, there is a circuit missing its bushing collar. Although this might seem minimalistic, the bushing prevents the sharp metal edges from cutting into the wire insulation and starting a short. Recommend repair by a qualified person/electrician.

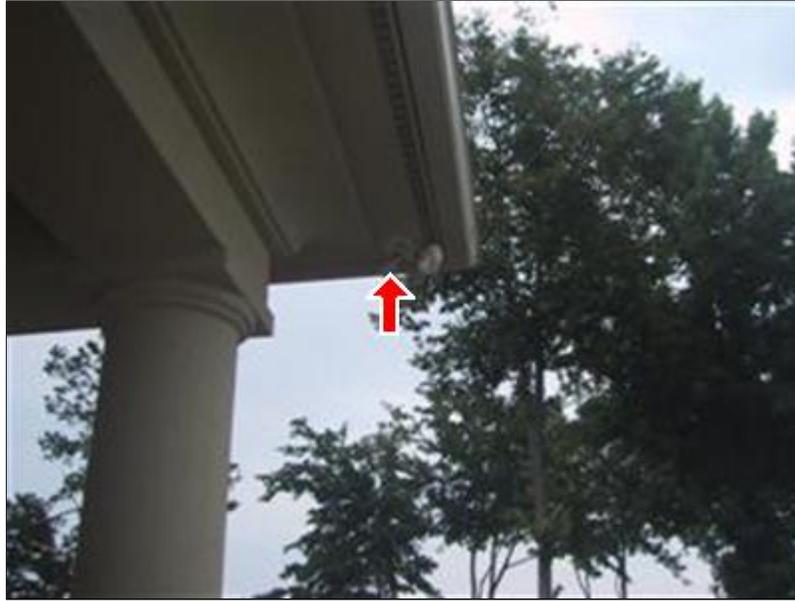
7.3 Picture 5 missing floodlight

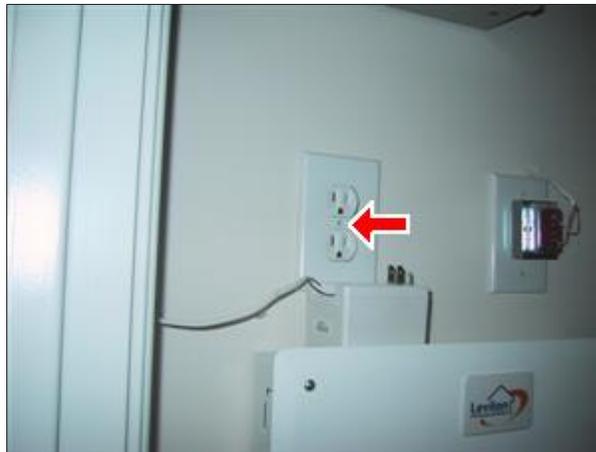
7.3 Picture 6

(4) Several outlets in the A/V room off the kitchen area are missing plate screws. Recommend repair by a qualified person/electrician

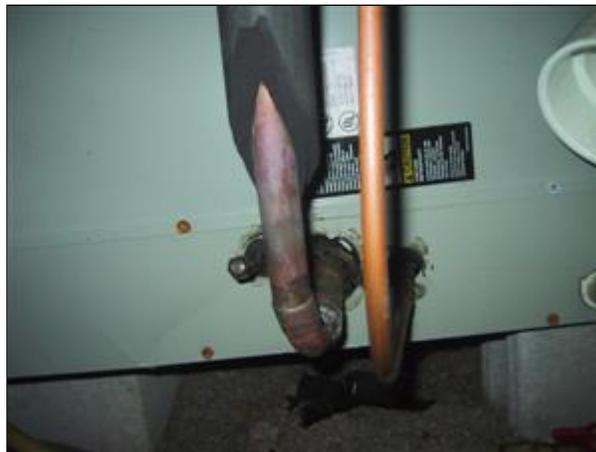
8.3 Picture 3

(2) The insulation on the line set on the furnace underneath the kitchen needs to be repaired and extended to the face of the furnace. Recommend repair by a qualified HVAC contractor.

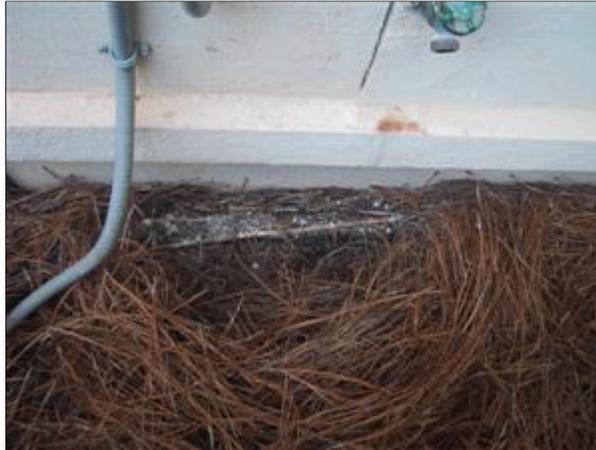
8.3 Picture 4

(3) The insulation on the line set to the exterior condenser pumps on the left side of home behind garage was buried, causing the insulation to deteriorate. Recommend repair by a qualified HVAC contractor.

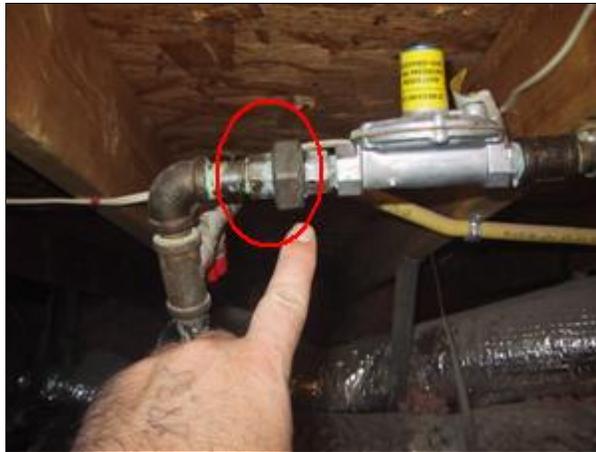
8.5 Picture 1

Noticed (by smell) a small leak at the lock nut just before the regulator in the attic area next to furnace. Recommend repair by a qualified HVAC contractor

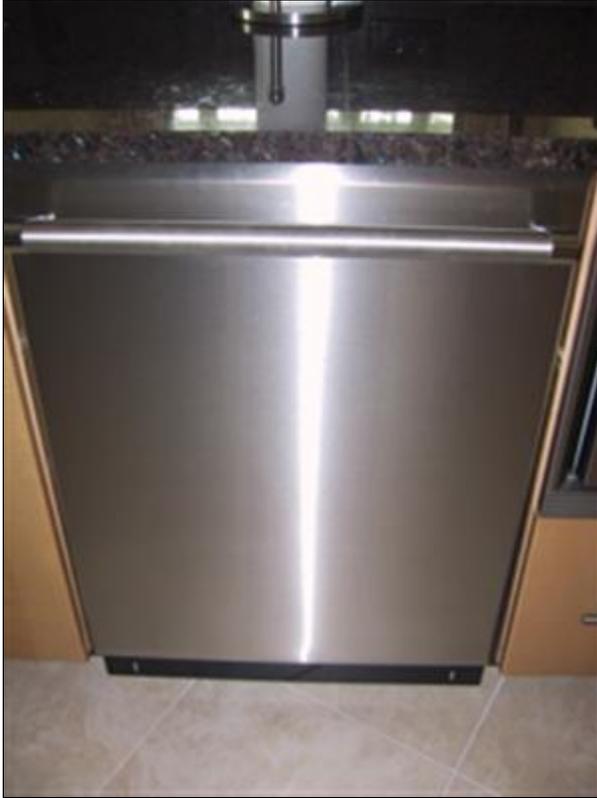
10.0 Picture 1

The dishwasher to the right of sink (if looking at sink) is hard to open. Based on further inspection, it is because the rubber flange at the bottom does not extend far enough over the bottom flange of the door, causing the rubber to "pop" once the door is opened far enough. This could be a manufacturer defect, as there appears to be no adjustment mechanism to manually alleviate this. Recommend further evaluation and/or repair by a qualified person/contractor.

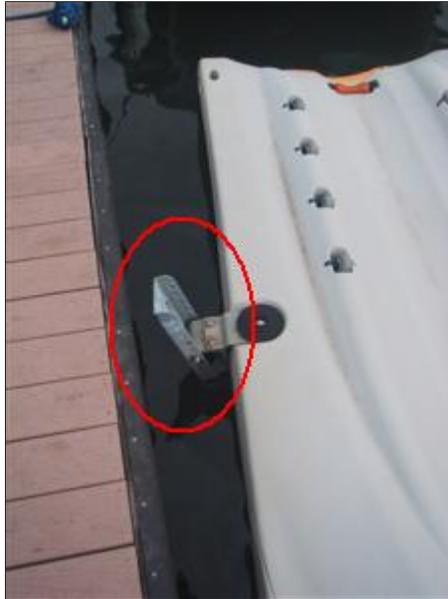
13.3 Picture 1

(1) The connector for the watercraft vessels has become detached from the deck. Recommend repair by a qualified person/contractor.

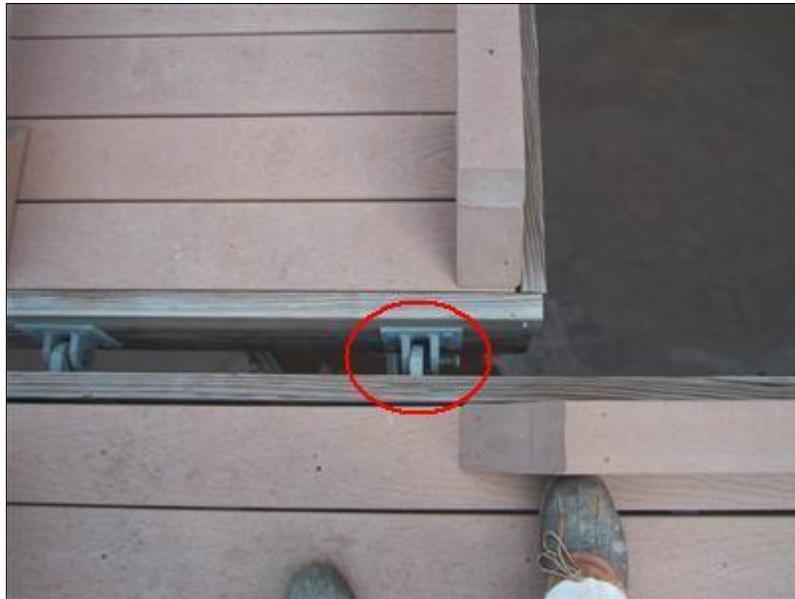
13.3 Picture 2

(2) The right hand bolt which attaches the "gangplank access ramp" to the boat dock apparatus is coming loose. Recommend repair by a qualified person/contractor.

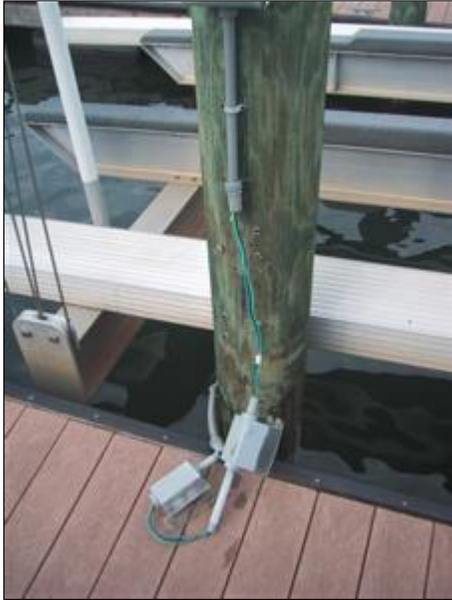
13.6 Picture 1

The GFCI outlet and circuit to power the lift are damaged. Recommend repair by a qualified electrician.

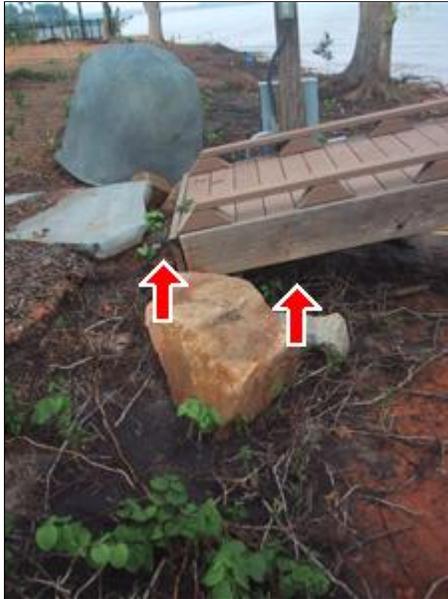
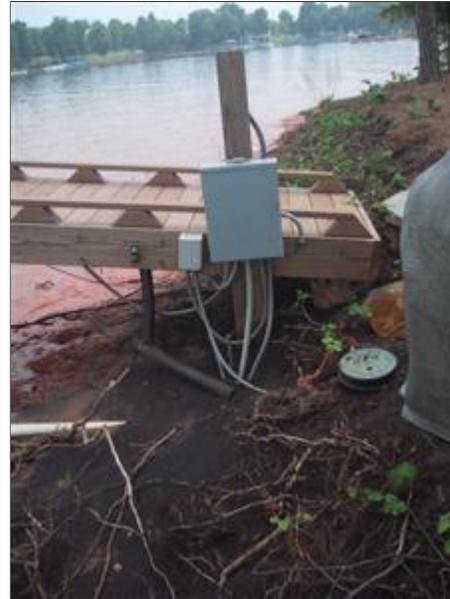
There is erosion occurring at the entrance ramp to the dock. Although there is a large boulder and a pylon supporting both sides of the ramp, careful monitoring of this situation should be maintained.
