Inspection Report

Property Address:
108 Conway Court
 Mooresville NC 28117

Envision Home Inspections, LLC

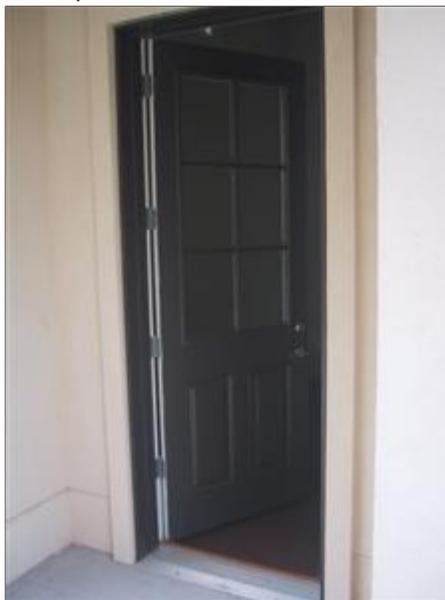
2.1 Picture 1

(1) The entry door to the detached garage needs to be adjusted. I had to "pull up" on the door to get it to latch. Recommend repair by a qualified person/contractor.

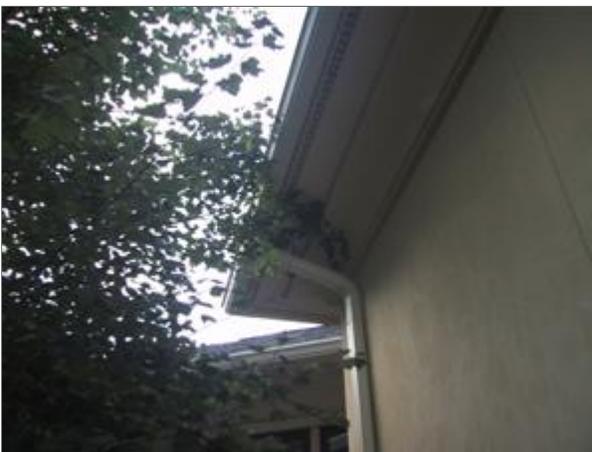
2.4 Picture 1

There is a tree on the right side (if facing house from front) rear which needs to be trimmed. It is hitting the cornice and fascia and could pose further damage if not trimmed back during the growth season. This also contributes significantly to clogged gutters.

Recommend repair by a qualified person.

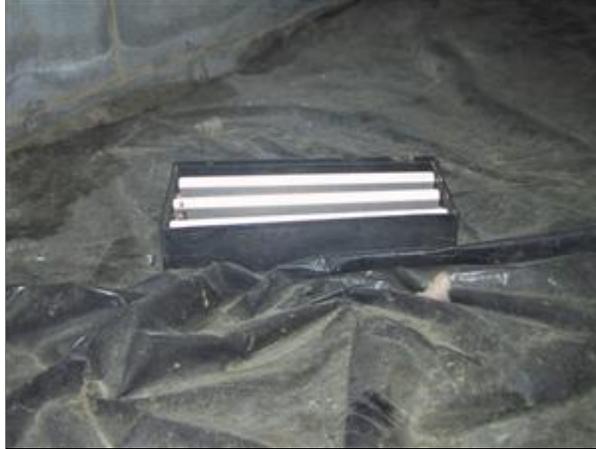
5.0 Picture 2

(2) In the crawl, there are several automatic damper/louvers which need to be replaced/re-attached to their respective vents.

Recommend repair/replacement by a qualified person/contractor.

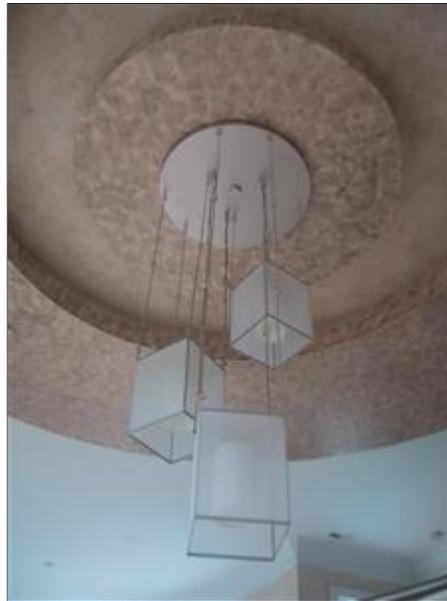
7.3 Picture 4 Main light, nor accent lighting would come on

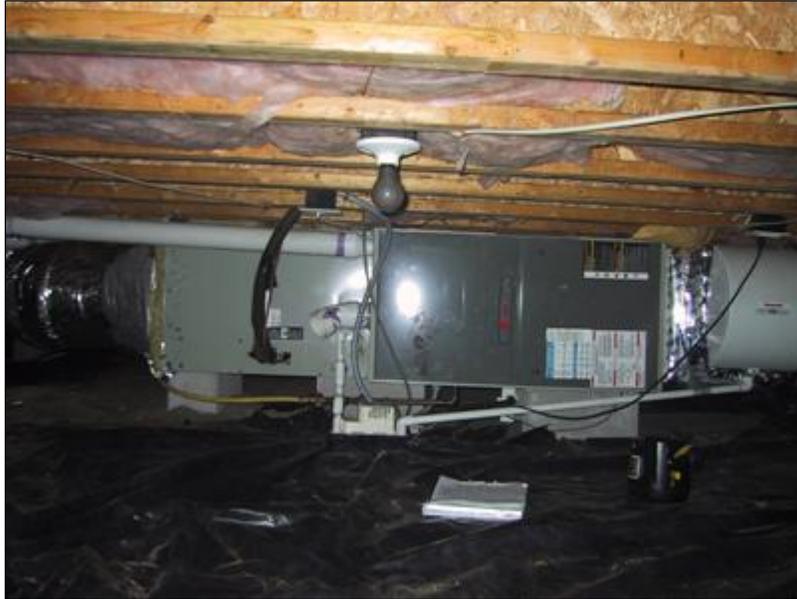
gas furnace under kitchen area (light bulb is out)

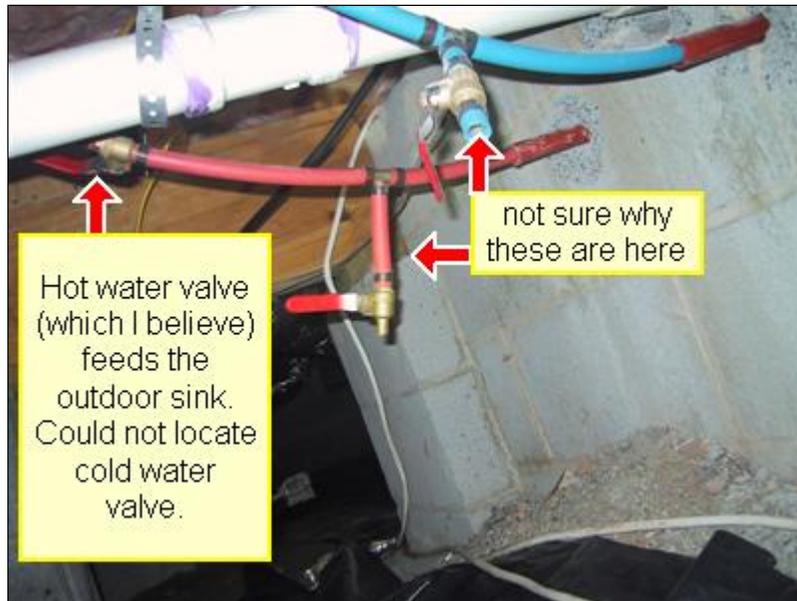
12.3 Picture 2

In addition, and as shown in the picture, there are two branches (one coming off of each line) in which I cannot determine what they are used for. Based upon my determination, they are at best confusing and at worst a detriment to possible moisture and water in the crawlspace should someone become confused and open the wrong valve.

I recommend evaluation and or repair of these lines and, in addition, evaluation and repair of the outdoor faucet/sink apparatus.

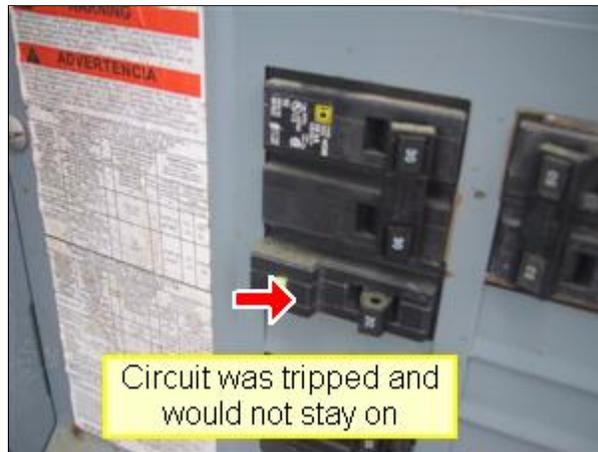
13.6 Picture 2

The GFCI outlet and circuit to power the lift are damaged. Recommend repair by a qualified electrician.

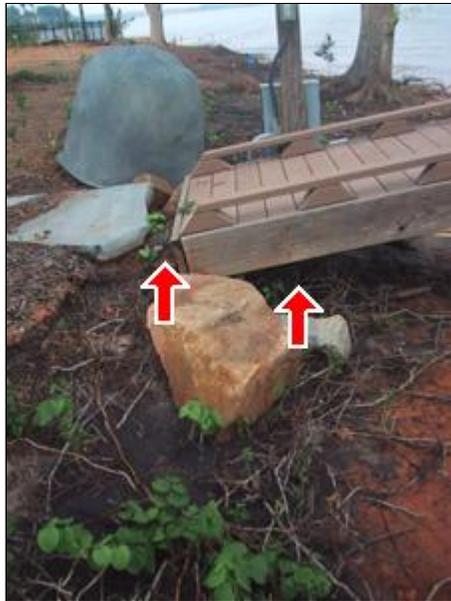
13.8 Picture 1

There is erosion occurring at the entrance ramp to the dock. Although there is a large boulder and a pylon supporting both sides of the ramp, careful monitoring of this situation should be maintained.

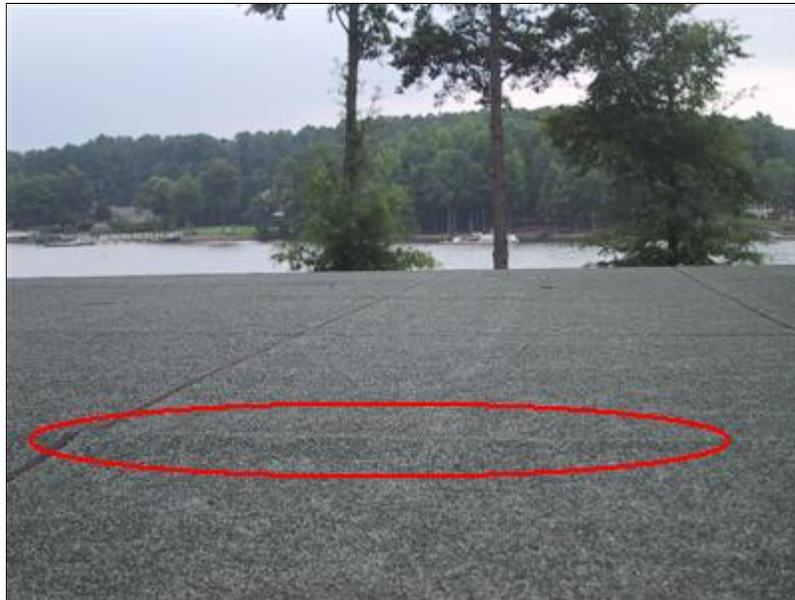
1.0 Picture 2

There were several areas over the covered back porch (covered with roll roofing) which exhibited "bubbling", although I could see no readily apparent holes. This will need to be monitored further, as roll roofing is more susceptible to leaks at seams and "bubbling", and typically has a shorter life span than conventional asphalt/fiberglass shingles.

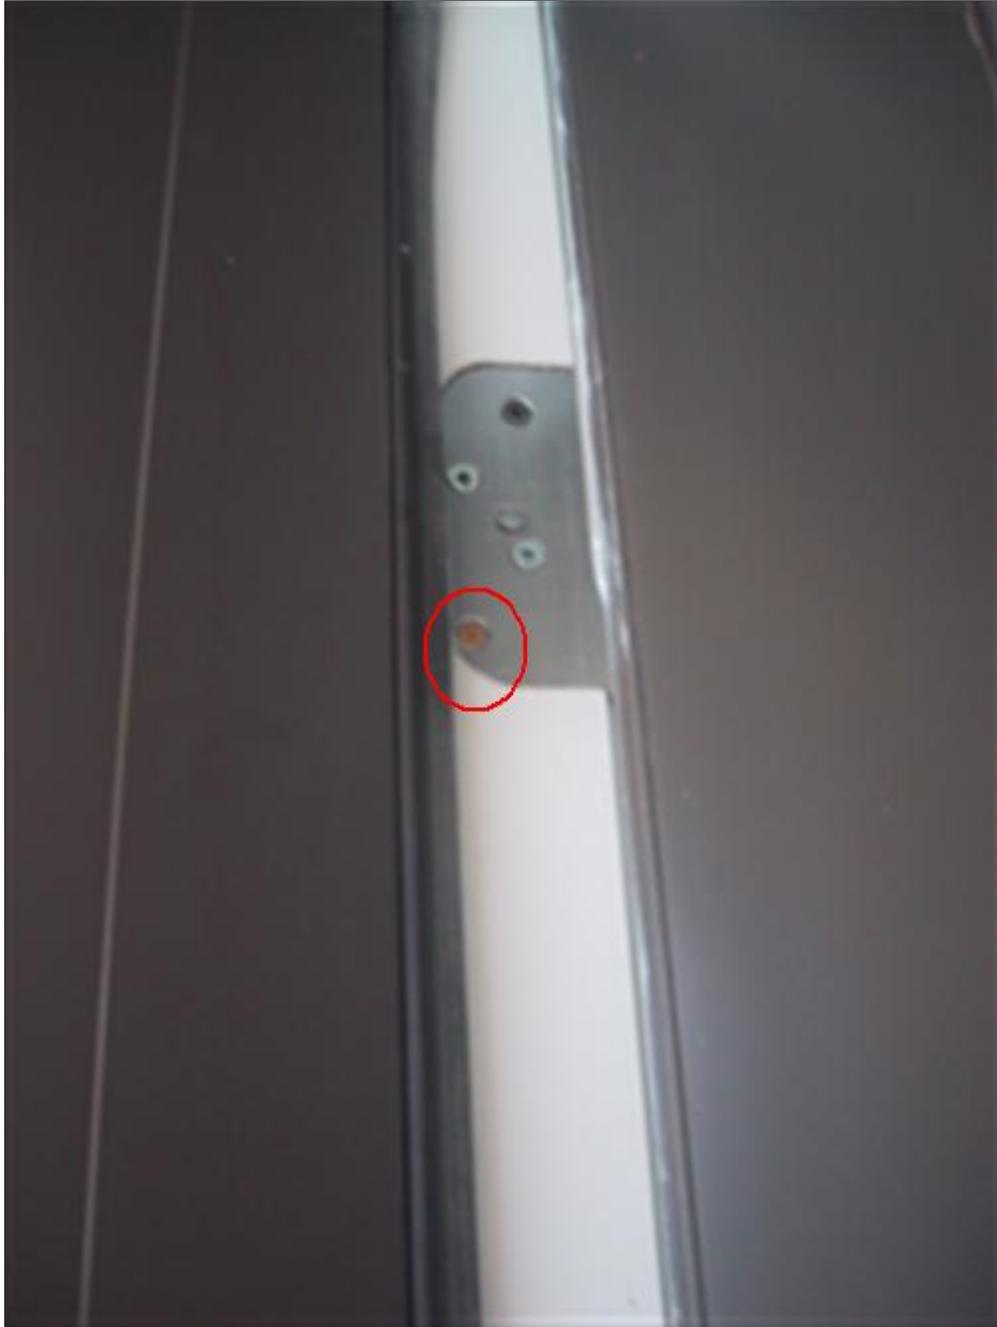
2.1 Picture 2

(1) The entry door to the detached garage needs to be adjusted. I had to "pull up" on the door to get it to latch. Recommend repair by a qualified person/contractor.

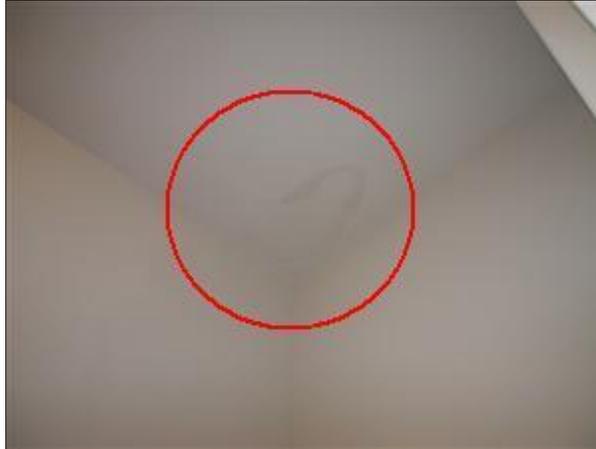
4.0 Picture 1

The ceiling area in the closet of Bedroom 1 (first at top of stairs), has a water stain on it in the corner. I went into attic to try to find where this may be coming from. There were no visible condensate lines in the area, so the probability that it came from a shingle/flashing problem is high. However, I could not specifically locate the source. This could be an active leak, or could have already been fixed and the paint repair just overlooked, as it was dry to the touch. Recommend the ceiling paint be touched up, and further monitoring after heavy rains.

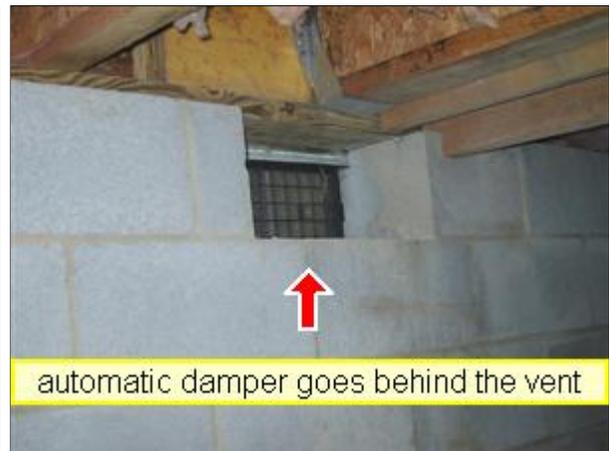
5.0 Picture 3

(2) In the crawl, there are several automatic damper/louvers which need to be replaced/re-attached to the their respective vents.

Recommend repair/replacement by a qualified person/contractor.

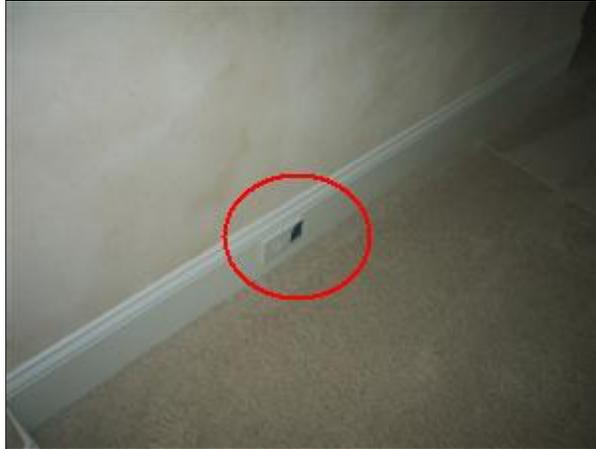
7.3 Picture 1

(1) The outlet in the hallway on the 2nd floor leading to the bedroom and exercise room did not show any voltage or current to it. Recommend evaluation and/or repair by a qualified person/electrician

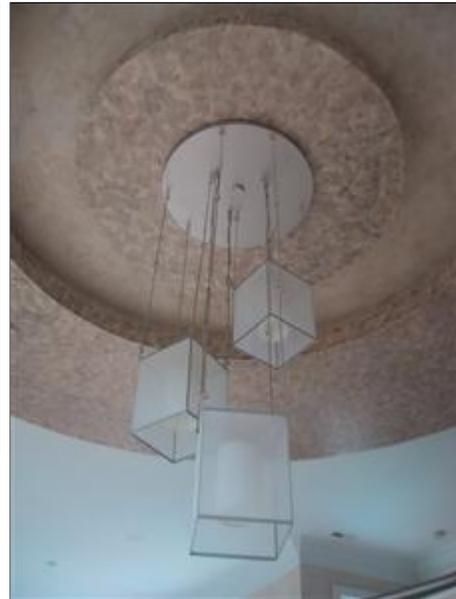
(3) There were numerous switches in which I could not ascertain what they controlled. **They are marked with blue painters tape.** Also, there are numerous lights either missing or burned out, on the exterior as well as interior. (left side of home *in the crawlspace* as well). Here are some possibilities for the marked switches:

7.3 Picture 4 Main light, nor accent lighting would come on

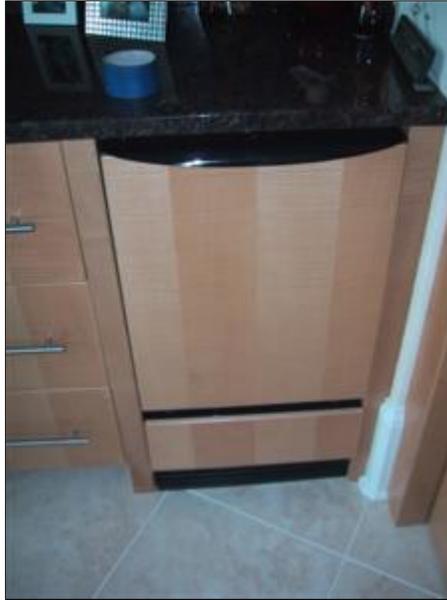
10.6 Picture 1

The ice maker next to the pantry door is not working properly. Recommend repair/replacement.

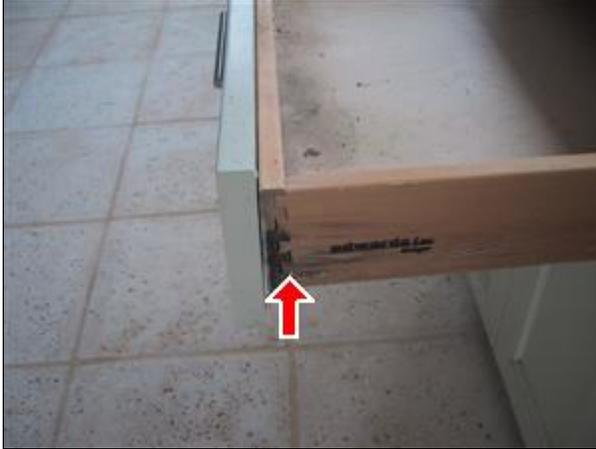
12.1 Picture 1

The outdoor cabinetry and some of the drawers are warped and are coming apart at the dovetail joints. In addition, some of the surfaces inside the cabinets have mold growth in them. Recommend replacement of all cabinets/drawers which need it, as repair of these types of joints usually does not work.
